# SUCEVIȚA MONASTERY. THE OVERPAINTING FROM NARTHEX AND EXONARTHEX. TECHNIQUE OF EXECUTION AND THE METHODOLOGY OF REMOVAL

Georgiana Zahariea \*

**Abstract:** The overpaintings found on the frescoes from Sucevița Monastery, date from periods that remain uncertain due to the rarity of written documents. Probably they were made because of the degradations that occurred in time or because of tastes. These interventions are made in oil technique or tempera, for that reason we can date them around the 19th century when there was this tendency of painting Orthodox churches in oil. The overpaintings are placed in key position, on the lunette, facilitating access from exonarthex to the narthex or from narthex to the tomb room. In terms of iconography, the overpaintings covered representations like: *Anastasis / the Resurrection; The Holy Trinity of the New Testament and Virgin Mary with the thief represented in heaven (detail from the Last Judgement)*. The present paper tries to make a comparison among the three surfaces with overpainting, bringing technical arguments regarding the differences between them. At the same time, the paper presents details about the methodology applied to clea

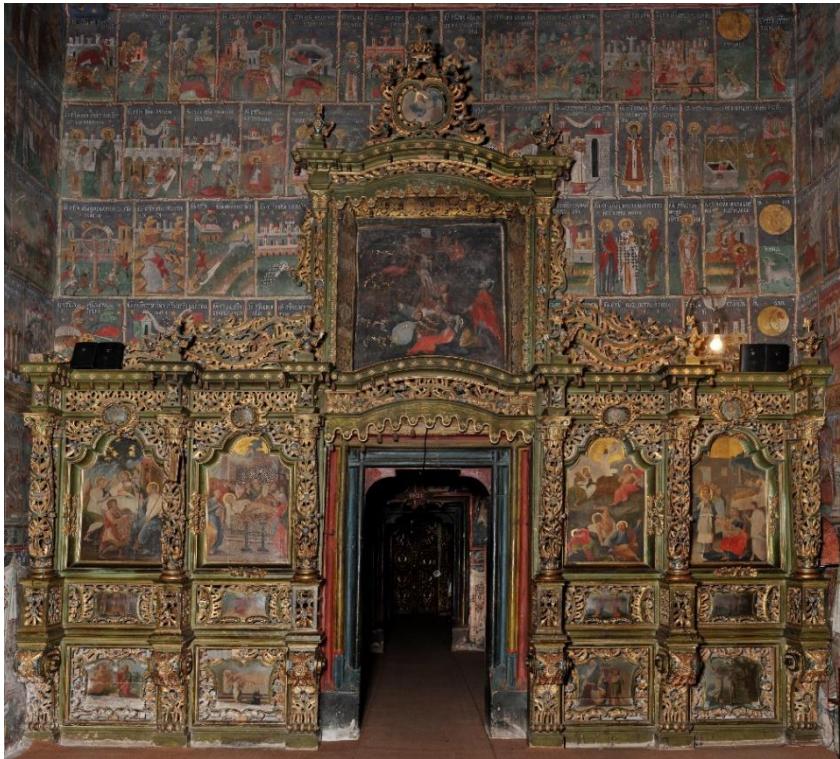
Fig. 1. Sucevița Monastery, narthex, general view with the iconostasis from the eastern wall, before restoration.

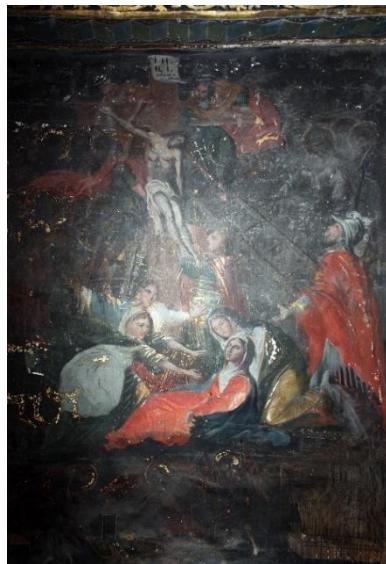
From the compositional point of view, the mural overpaint representing the *Descent from the Cross of Jesus Christ* is concentrated in the central plane, where Jesus is surprised in the dramatic moment when He is alight from the cross. At His feet, we can recognize the Holy Women with the Virgin Mary and also two soldiers (Fig. 3). On the one hand, the oil painting uses the *chiaroscuro* technique in which the portraits are treated very refined, with a divine light concentrated on the Virgin Mary and Jesus left as a very subtle detail of interest. On the other hand, the dark parts of composition were covered only partially and very carelessly.

Fig. 2. Sucevița Monastery, narthex, image with the representation “*The Descend from the Cross of Jesus Christ*”.

In the first stage, we removed the deposits of dust and soot from the overpaint, to see the real chromatic scale of the oil paint. After a few cleaning test, it was decided that the best procedure is the one that combines the mechanical method using brushes, *wishab* and soft gums, and chemical solution – ammonia water or alcoholized water. Following these tests, we observed a discontinuity of the last layer of protection - varnish, that had consistent clumps due to a technical vice. Also, it has been observed that the 19th century paint layer was applied in a thin semi – transparent film. For this reason, the underlying paint layer was visible and we could see the original painting.

To remove the overpainting, we have made tests in the areas where we could see the presence of the original painting underneath. A favorable result was obtained using a mixture of solvents placed in a compress. The contact time for the compress dependeds on the state of the oil thickness that fluctuates from one area to another. To achieve a satisfactory result, the method of cleaning was alternated with compresses impregnated with a solution of ammonium carbonate. After a few cleaning tests, we agreed that the removal of the overpainting should be done differently, depending on the characteristics

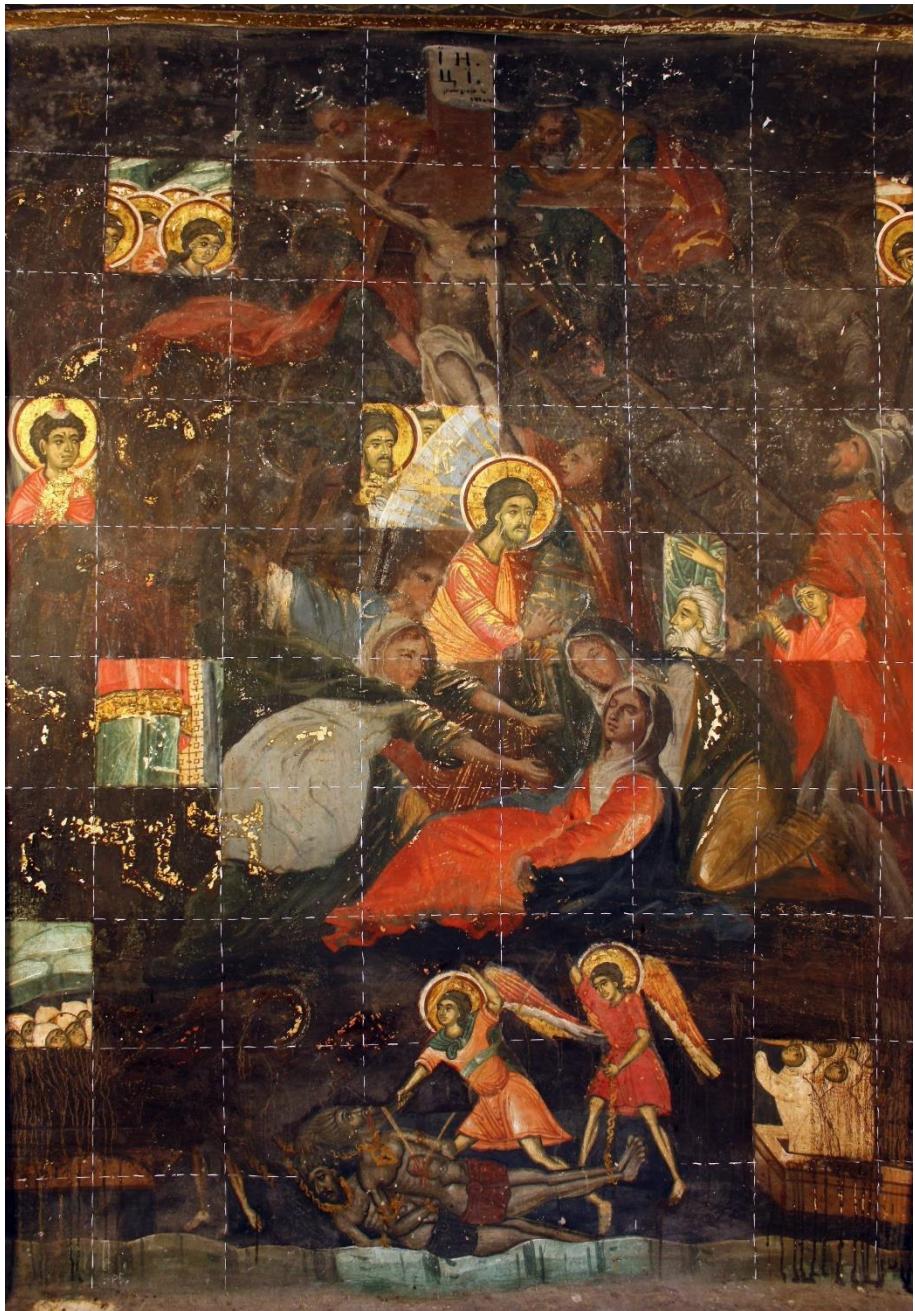
Fig. 4. Sucevița Monastery, narthex, detail during the work

of the oil painting but mostly of the original “*a fresco*” (Fig. 5). The strategy applied to remove the 19th century overpainting was influenced by the unaware of the conservation status of the “*a fresco*” painting and more specifically, if the color is detached from the support. For this reason, we preferred a cautious approach, progressing in the evolution of cleaning step by step, using a network of panels (Fig. 4).

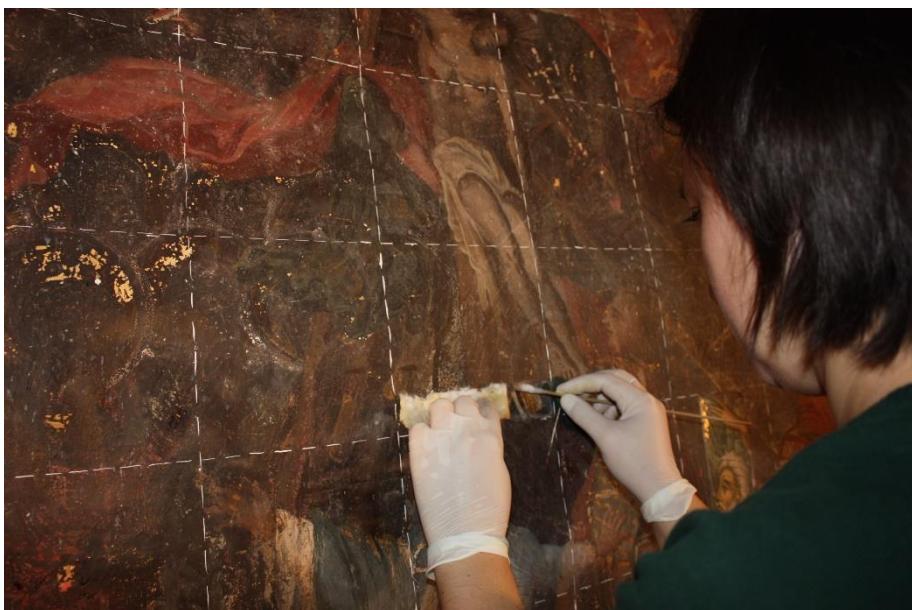
Fig. 5. Sucevița Monastery, narthex, the representation “*the Descend from the Cross of Jesus Christ*” detail during the work.

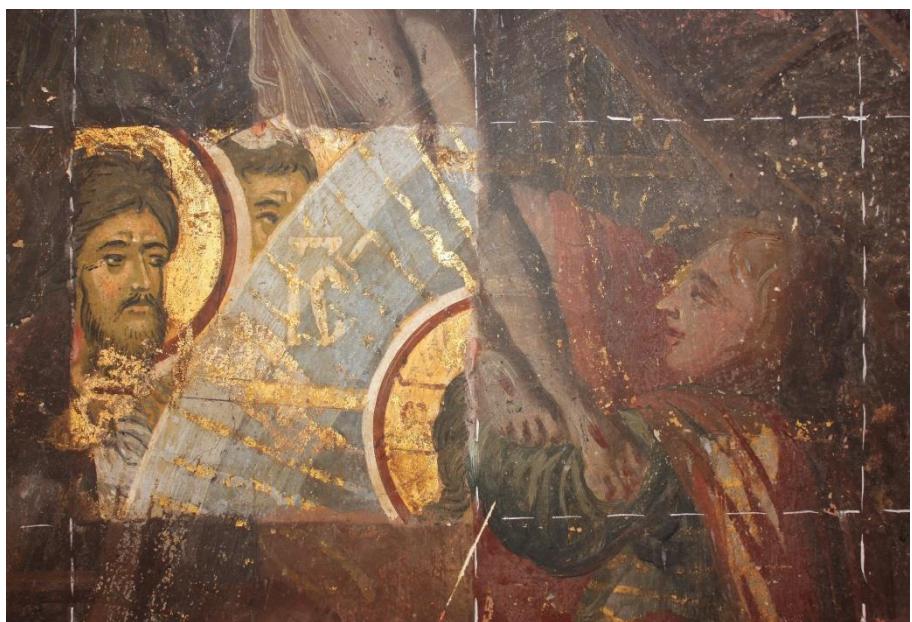
In the end, after the removal of the overpaint, it was found that on the areas where the consistency of oil painting was big, the adherence to the original painting was much higher (Fig. 6). This phenomenon happened due to the differentiated impregnation of the surface that increased the absorption in the original paint layer. For this reason, it should be noted that the “*a fresco*” painting marked by the presence of the overpainting, will suffer degradations that are specific to oil painting (Fig. 7).

Fig. 6. Sucevița Monastery, narthex, a comparative image with areas covered by overpainting and with the original “*a fresco*” painting.

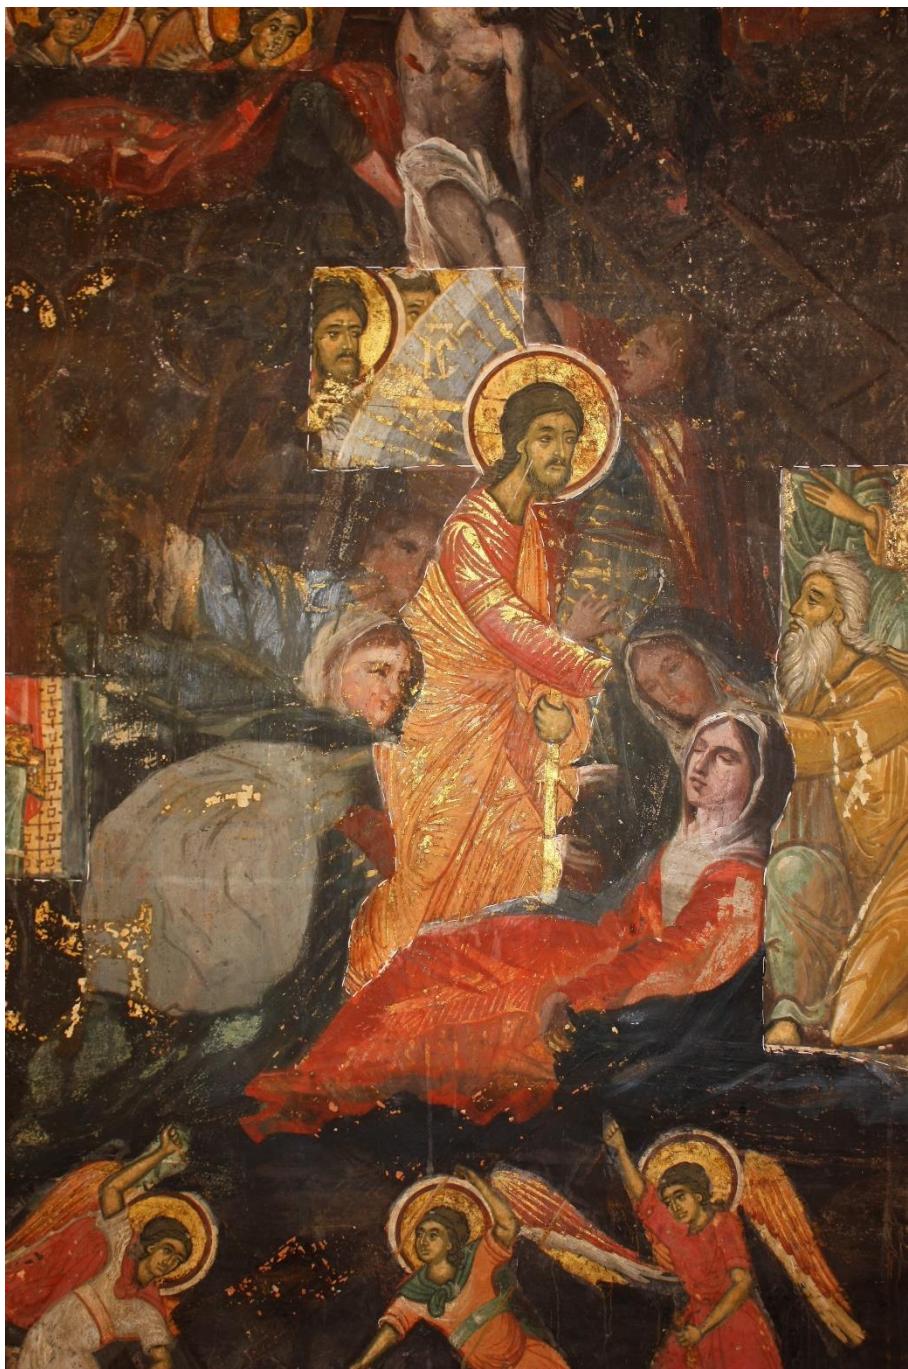
Fig. 7. Sucevița Monastery, narthex, a comparative image with areas covered by overpainting and with the original “*a fresco*” painting – rediscovering the original image of Jesus Christ.

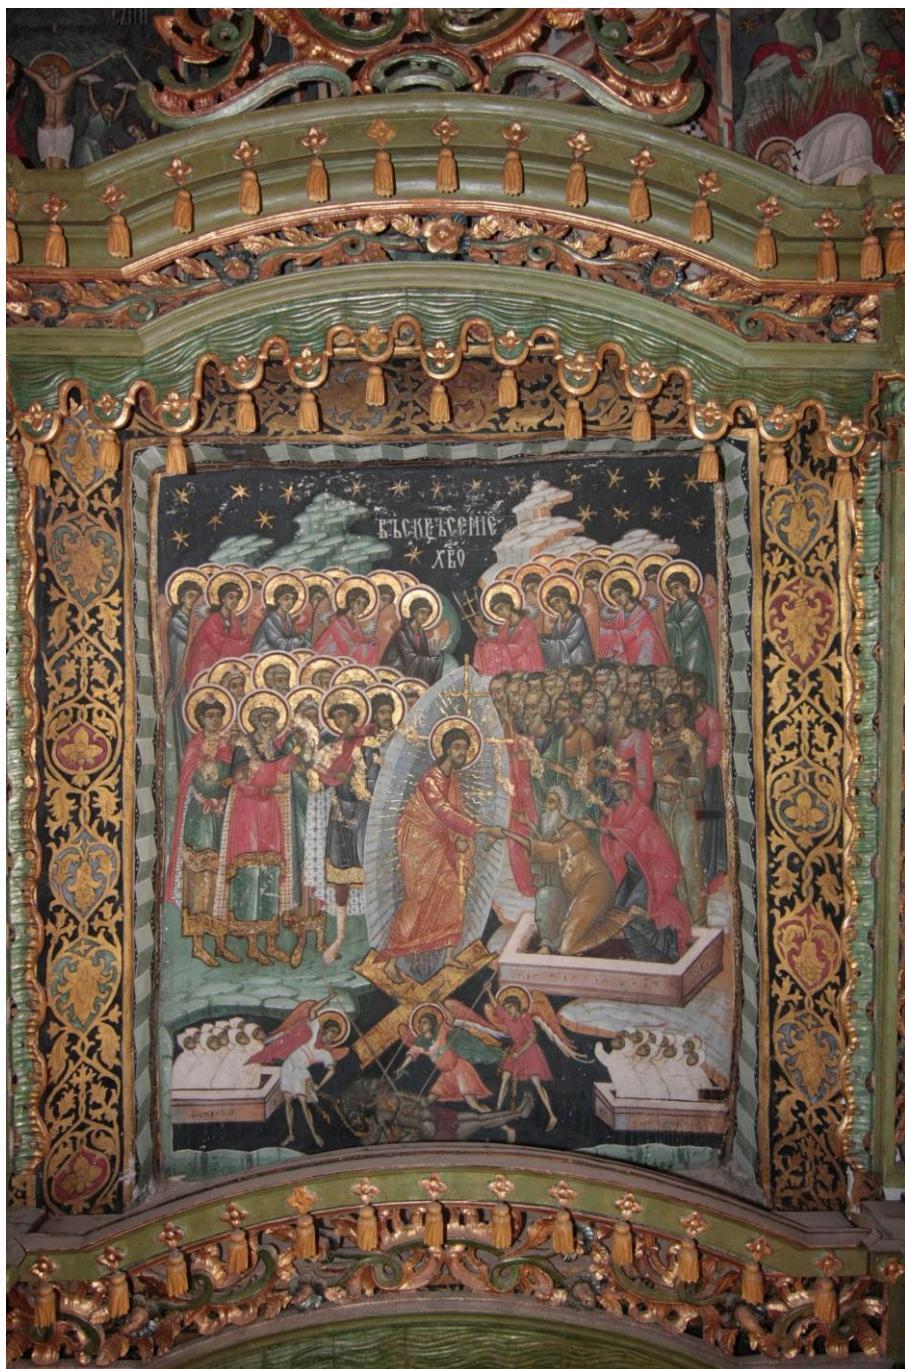
Fig. 8. Sucevița Monastery, narthex, image with the original painting.  
The feast icon – Anastasis / the Resurrection.

Finally, the restoration process managed to fully recover the original “*a fresco*” painting in which it was represented the feast icon of the church – *the Resurrection* (Fig. 8). Thus, if the overpainting from the 19th century presented *the Descent from the Cross*, an image to conclude that the events were dedicated to the Sacrifice of Jesus Christ, the 16th century painting brings to the community the representative image of the church that marks the transition from death to eternal life.

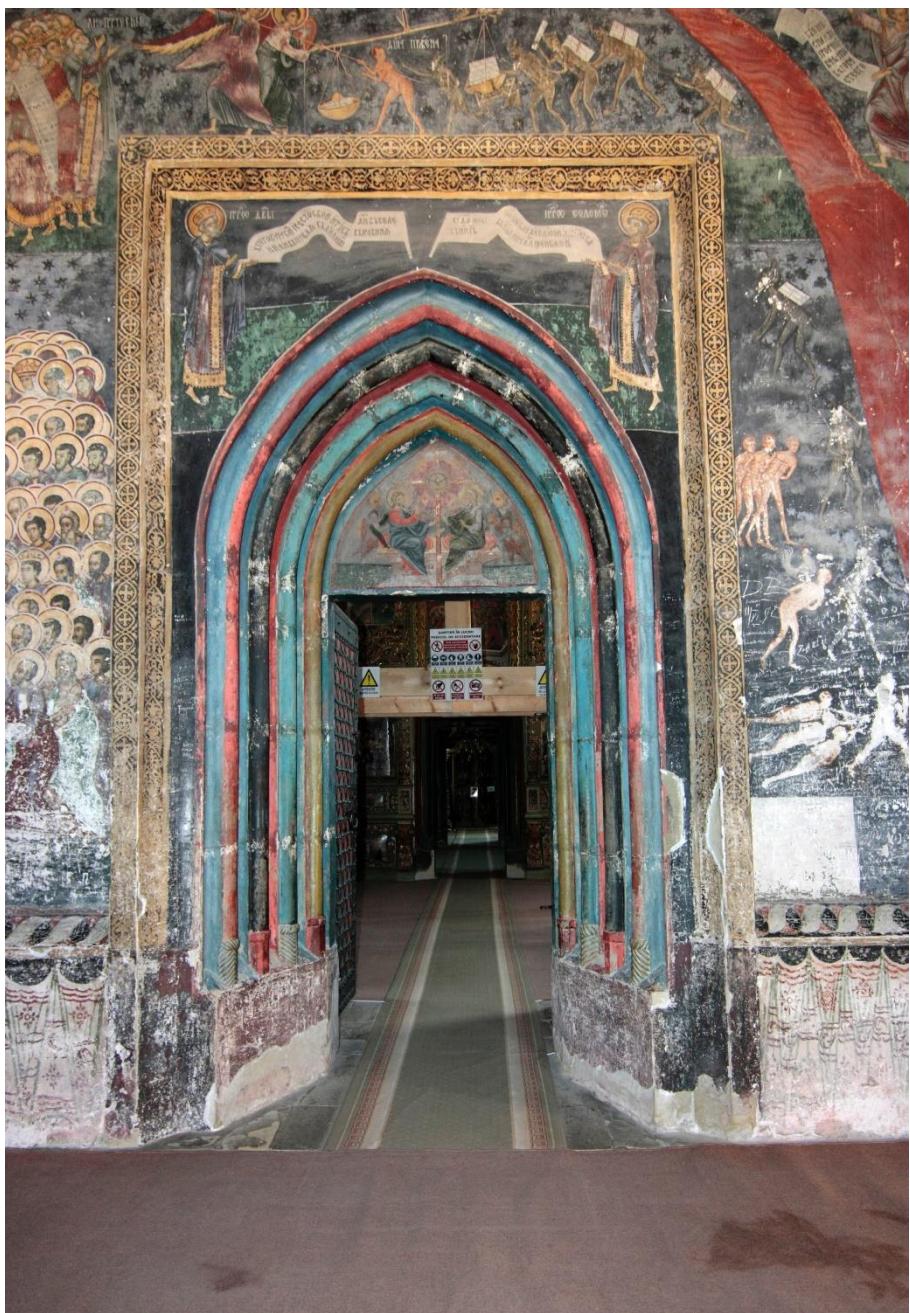
Fig. 9. Sucevița Monastery, exonarthex, general view with the entrance to narthex

started in this room (Fig. 9). Placed in the ample context of the *Last Judgement*, the icon of *The Holy Trinity* marks the moment when the believer passes from the preparatory to the sacred space, marking himself with the sign of the cross. Placed where it is generally painted the feast icon, at Sucevița, the founders choose to represent the icon in narthex and not in exonarthex.

- Fig. 8. Sucevița Monastery, narthex, image with the original painting. The feast icon – Anastasis / the Resurrection. Photo: G.Z.
- Fig. 9. Sucevița Monastery, exonarthex, general view with the entrance to narthex. Photo: G.Z.

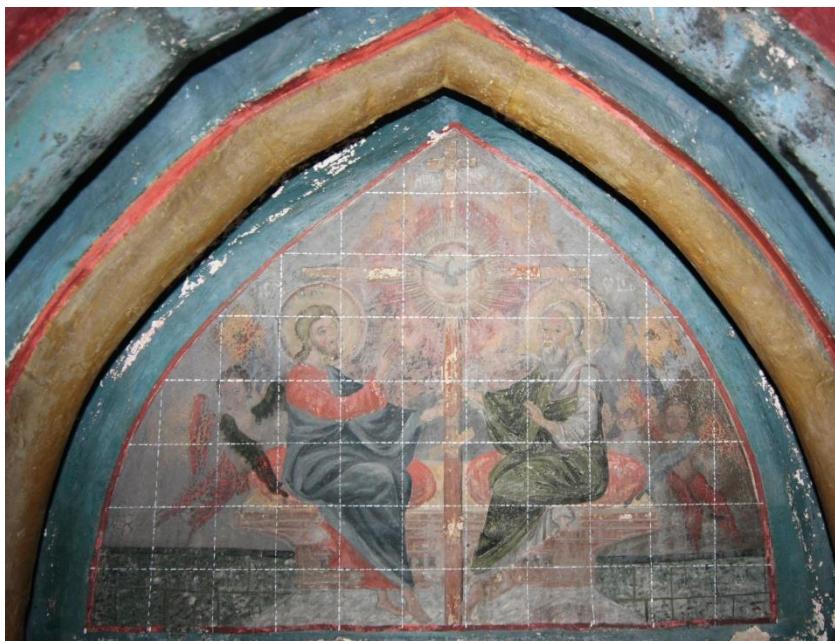
Compositionally, the western representation from the 19th century of the Holy Trinity, presents two characters – Father and Son – standing on a banquette sustaining together the cross. At the intersection of the tow bars, it is represented the Holy Spirit as a dove, accompanied by the monogram of Christ and framed in a circle that scatters light rays. Behind each person on the banquette, it was painted a seraph with six wings and a human body (Fig.10).

Fig. 10. Sucevița Monastery, image with the Holy Trinity, before restoration

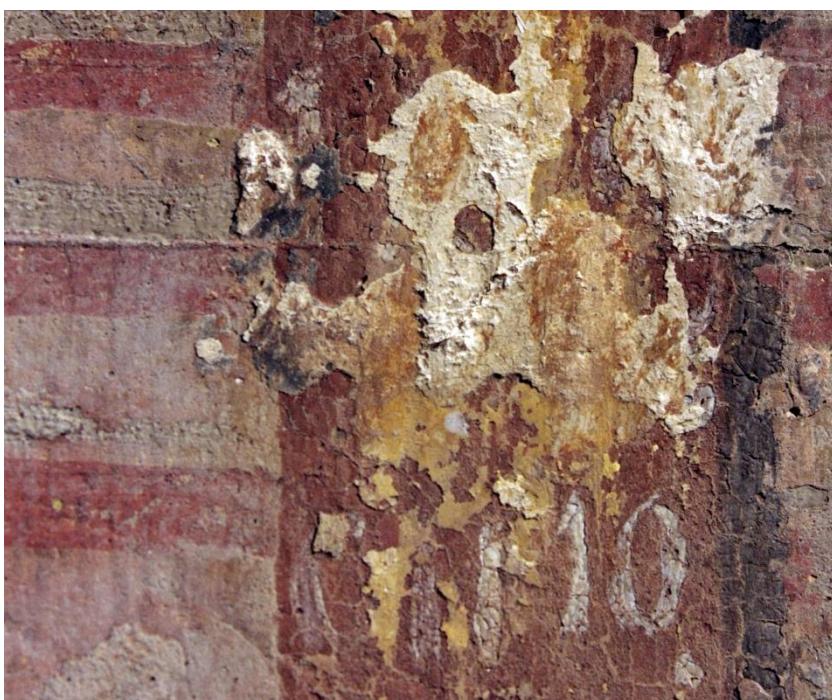
In the lower part of the scene, at the base of the cross, we could distinguish the presence of an inscription that tried to date the intervention. Unfortunately, when the restoration started, only the last two digits were visible – 10 (Fig. 11).

Fig. 11. Sucevița Monastery, exonarthex, detail with the inscription from the overpaint of the Holy Trinity.

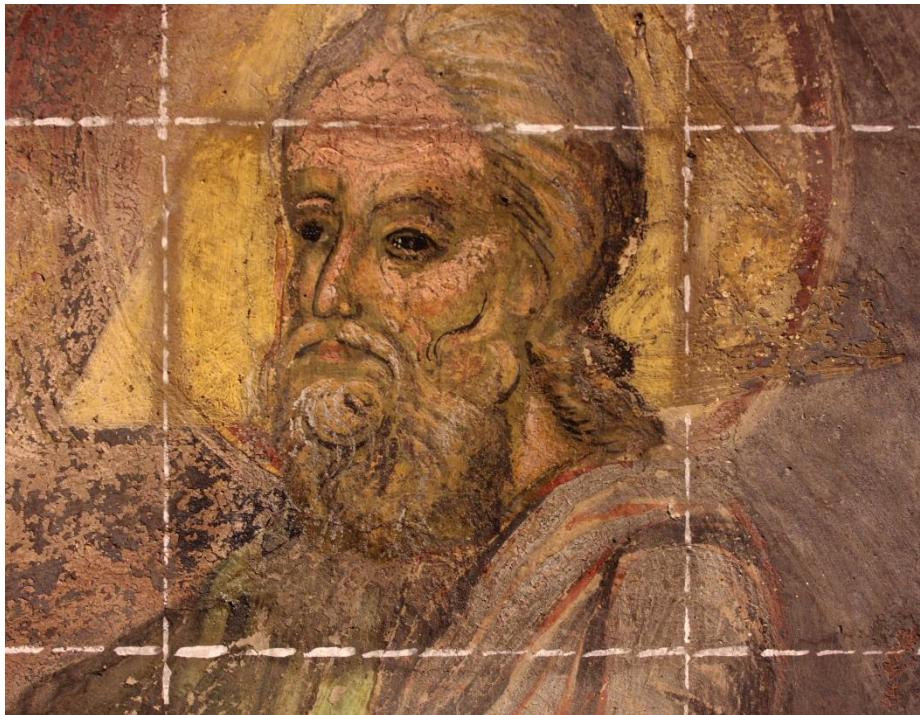
In this case also, the overpaint was done directly on the original painting, without any other intermediate layer. The faces of the characters were partially covered: forehead, nose, cheekbones, preserving the original anatomy and drawing (Fig.12). Also, at the edge of the scene we could see clear areas with “*a fresco*” painting, just as in the narthex (Fig.13).

Fig. 12. Sucevița Monastery, exonarthex, image with the overpaint of the Holy Trinity

The methodology applied to clean the overpainting is the same as the one used for the feast icon in the narthex. At the beginning, the surface was cleared of suspension of dust and sooted to distinguish better the colors of the overpaint and after that it was removed the overpaint using the same network of panels. As the overpainting was removed from the surface, the original composition started to be more visible. In the end, it was found that the overpaint followed the original composition and color. Major changes were found on the right character (Father); if before, He was wearing a green cloth with black shadows, after restoration it was discovered that He was wearing white clothes with blue smallt drawing. Also, the halo was modified, in the representation from the 19th century, Father was depicted with an equilateral

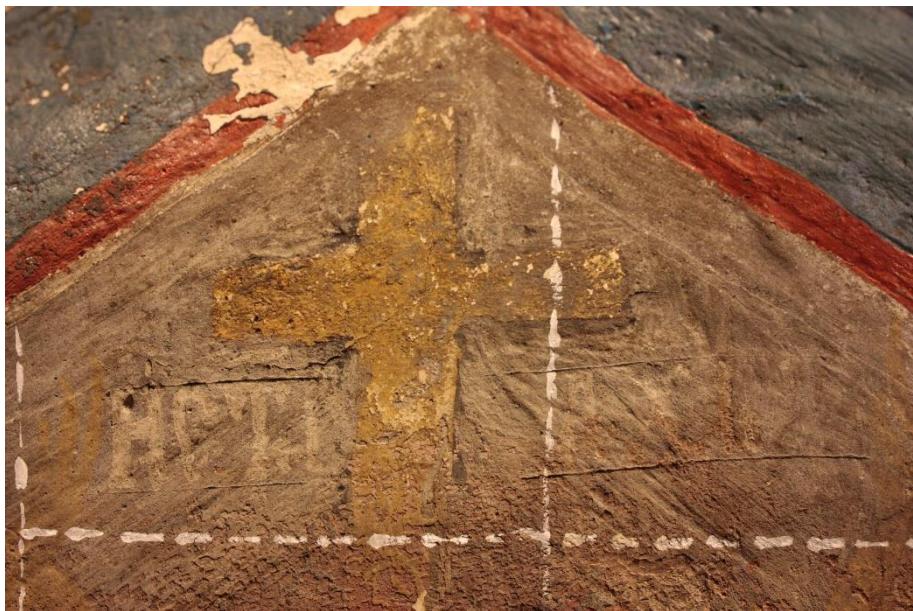
Fig. 13. Sucevița Monastery, exonarthex, at the edge of the scene  
we could see clear areas with “*a fresco*” painting

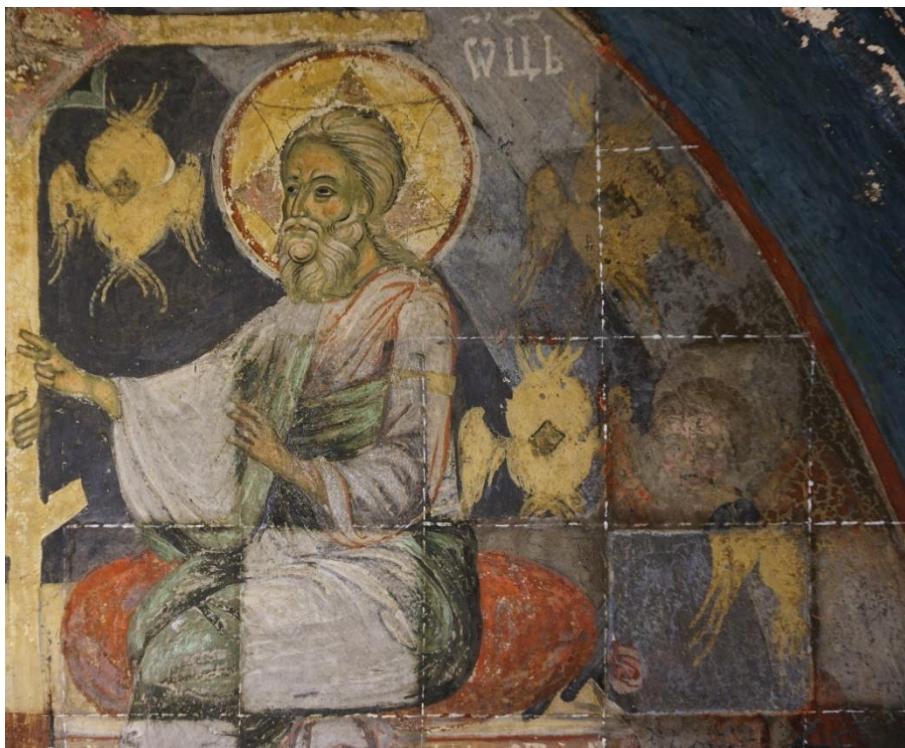
triangle around his head. In the original “*a fresco*” painting, He appears with a halo framed by a star, such as *the Ancient of Days* (Fig. 14).

Fig. 14 Sucevița Monastery, exonarthex, rediscovering the original image of the Father

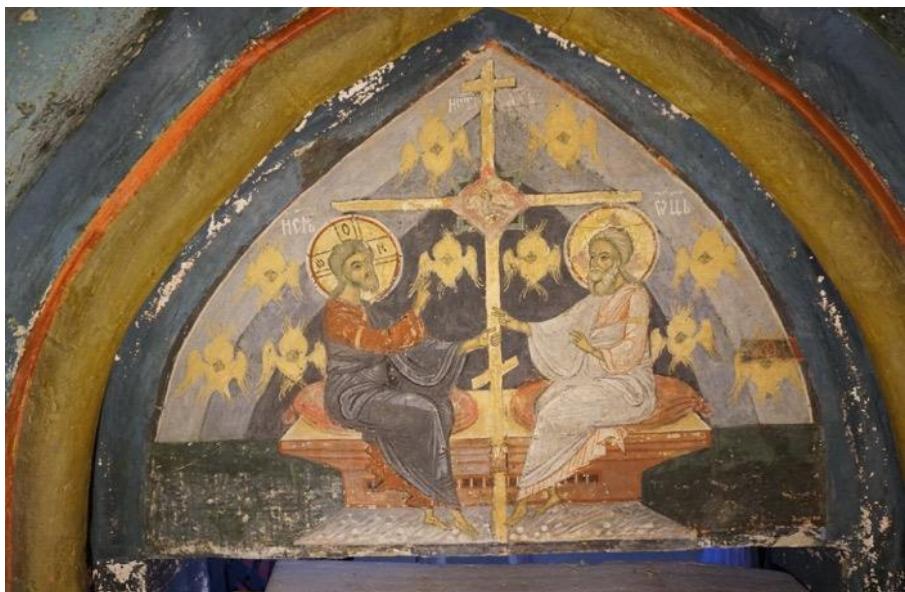
A new detail that the representation of the Holy Trinity brings after restoration, are the seraphs that surrounds the three characters. Their presence makes the whole composition more dynamic. An additional element is that the entire composition is inscribed in a mandorla. All these elements make the whole composition gain an eschatological interpretation (Fig. 15).

Fig. 15. Sucevița Monastery, exonarthex, the original image of the Holy Trinity

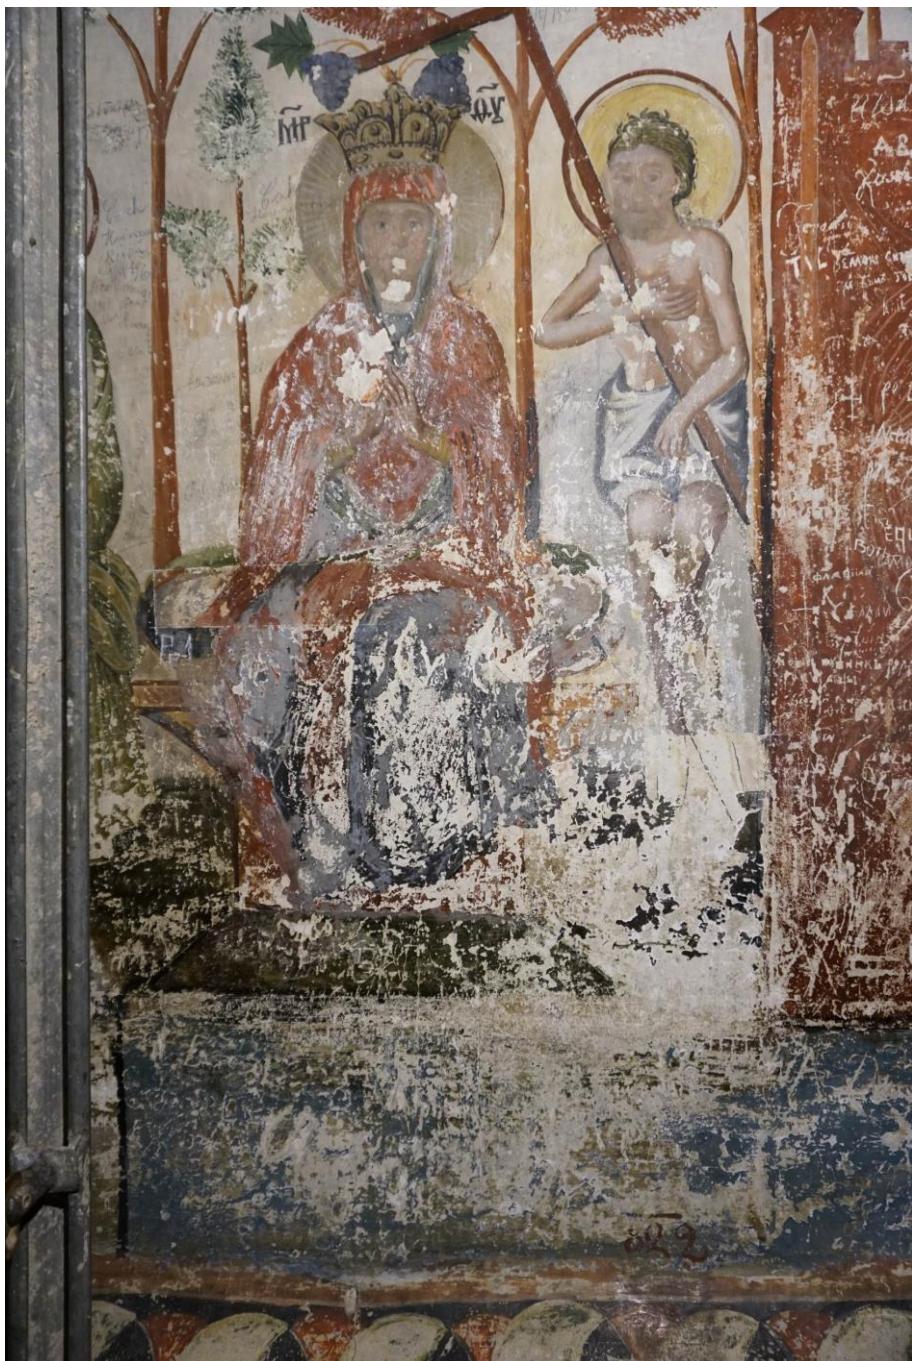
Placed at the level where the viewer has access, the area has suffered from large degradation caused by the human factor. Although the entire area presents many losses of color, the overpainting covers only two characters: Virgin Mary and the Thief (Fig. 19).

After a visual examination of the surface, it has been found that within the “lacuna” formed in the overpainting layer, there are elements of the original composition and the color range is significantly different. Also, the proportions of both characters were quite different from those of the overpainting. This was more evident at the thief; in the 19th century version, he was constructed with a bad anatomy and untowardly.

Fig. 19. Sucevița Monastery, exonarthex, detail with Virgin Mary and the thief in Paradise, with overpainting.

The removal of the overpaint was done mostly using mechanical methods because of the thin ground applied as a support for the overpaint, for that reason we could easily detach the painting.

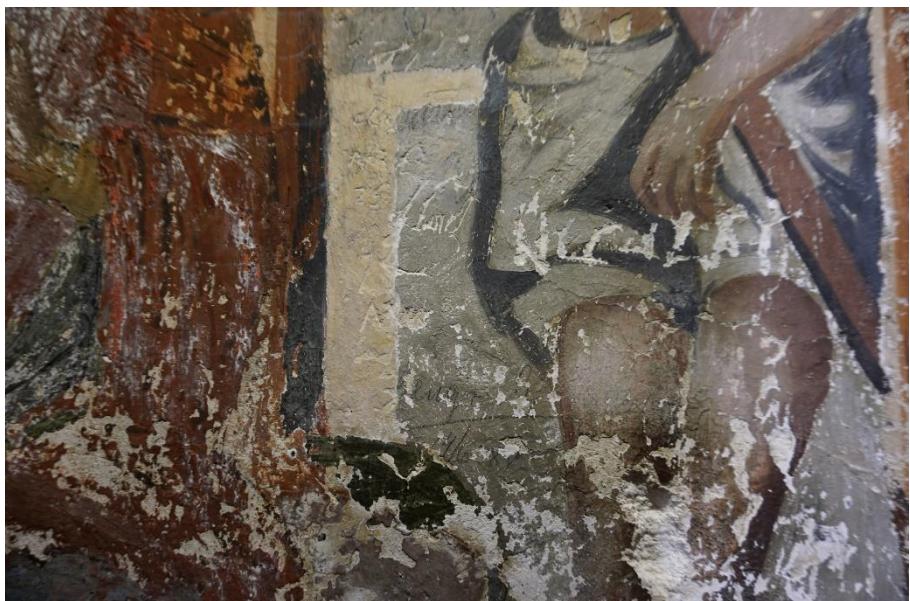
Fig. 20. Sucevița Monastery, exonarthex, detail during work.

The operation started in the neutral area, between the two characters. During the process of discovering the original painting, we started to observe elements of drawing and colour. In the first stage, it was uncovered the grey background applied over the white, the one that symbolizes Paradise (Fig.20). In the case of the thief, we rediscovered a slightly oversized character with specific colors from Sucevița. In the upper area, he conserves the overlays of the base tone and middle tone and the lower part preserves a sensitive preparatory drawing with the base tone.

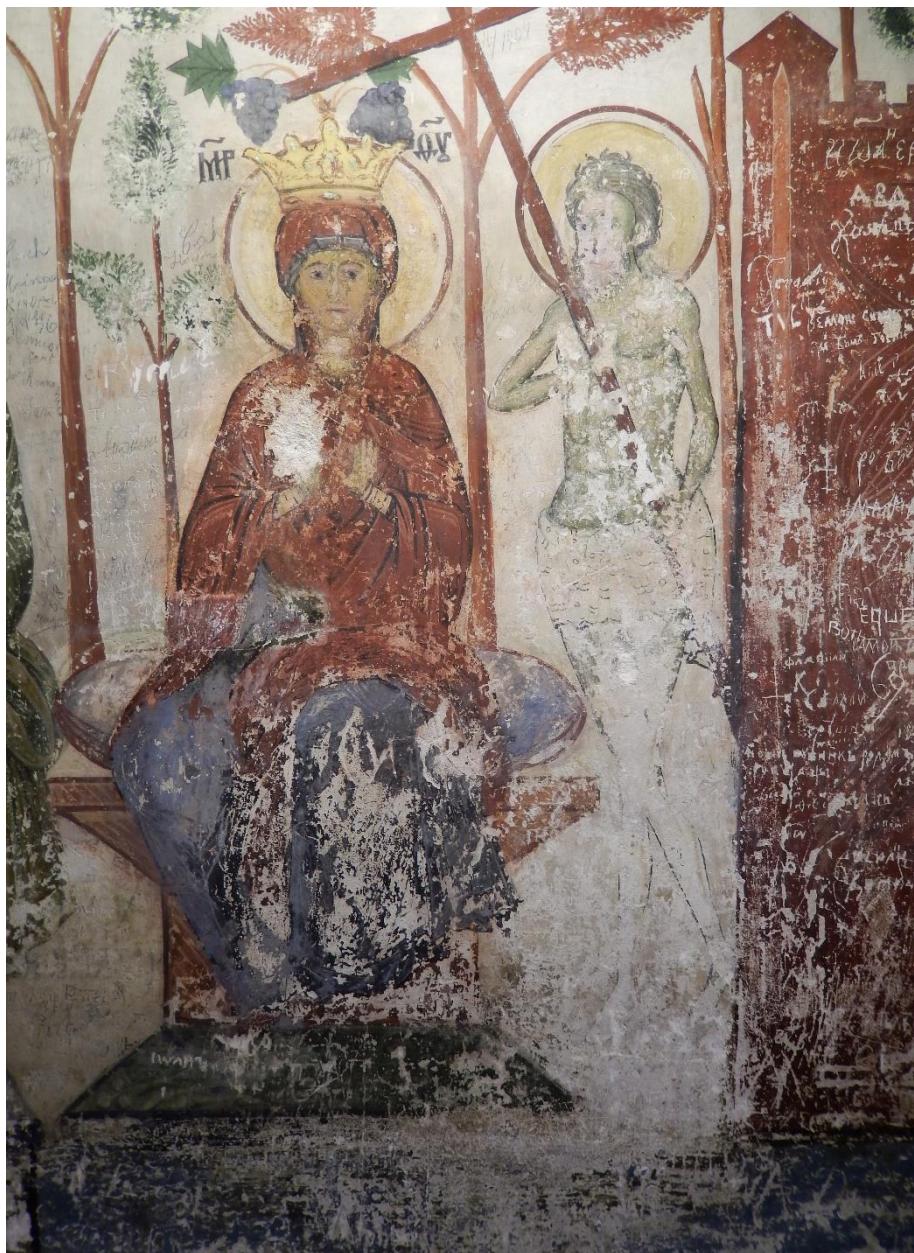
Fig. 22 Sucevița Monastery, exonarthex, Virgin Mary and the thief in Paradise, after restoration.

The overpainting of the Virgin Mary was removed applying the same methodology and in the end, the restoration process put in value a garment that respects the natural proportion, with a drawing that places the original painting in the post – Byzantine style (Fig. 22).
