# Notes on the Iconostas of St. Theodore's Church from Iași. Technique of execution, stylistic description and state of conservation

**Abstract:** This paper proposes an overview of the iconostasis of the Church *St. Theodore's* of Iași with mention of the execution technique, stylistic description of the registers that compose the iconostasis and also description of the state of conservation of the assembly. Information about the iconostasis is preceded by a brief description of the building architecture. The material is part of a research project that dealt with the technical expertise of the monument and its artistic components.

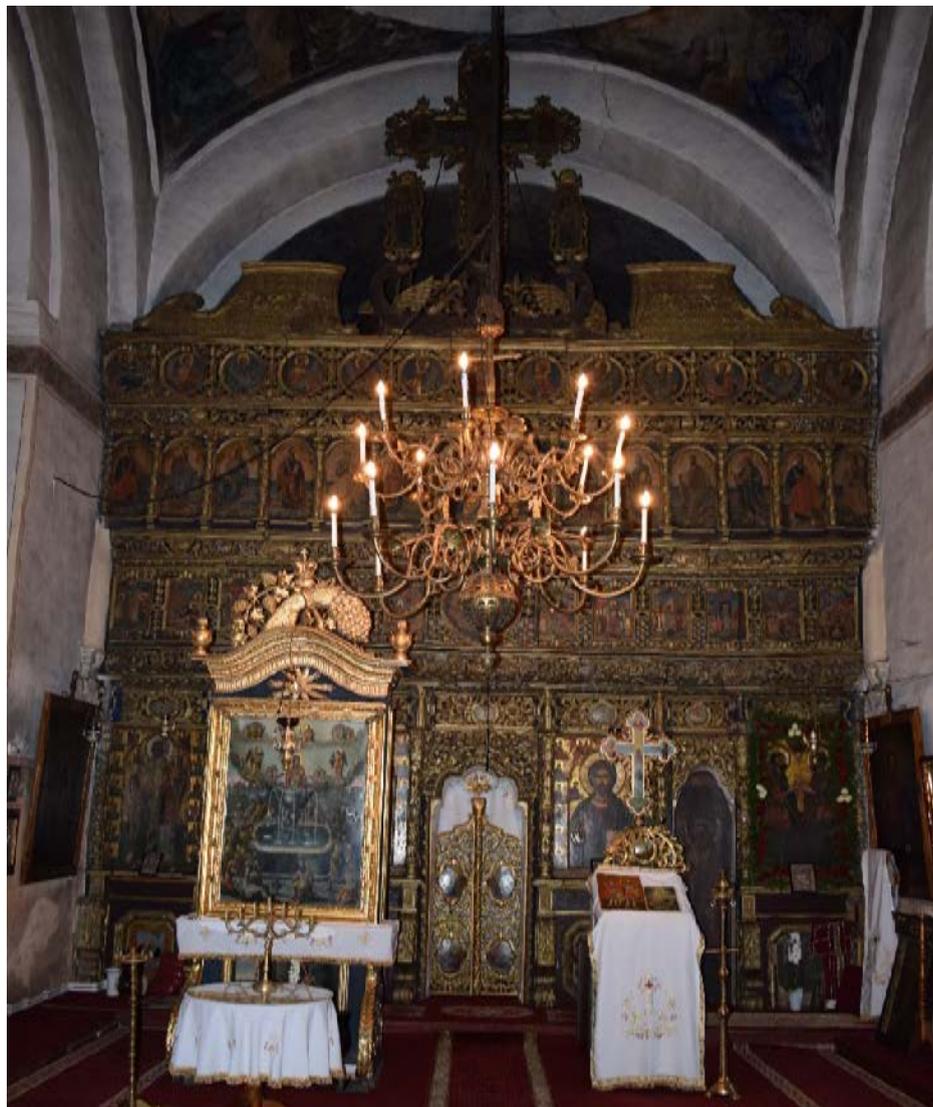
Fig. 7. Overall appearance of iconostasis

The iconostasis ensemble consists of overlapping registers, the superior ones being placed with a slight forwarding in the plane compared to the lower ones. As a technical peculiarity, it is noted that the registers above the royal one is made of merged wooden plates, over which, subsequently, the composition of the registers was transposed, the surfaces of the volumetric decoration being then fretted and carved. The areas with painting are not separated and applied by overlap, but they result from the planar structure of the merged panel. The pillars of the Royal registry and those from the Register of Apostles were worked separately and subsequently added to the Iconostasis, the first being fretted and sculpted, and the latter having a sculpted decoration without frets.

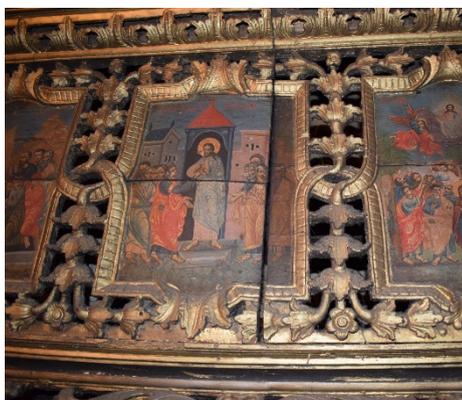
Fig. 13. Detail with the highlighting of the tile joints that compose the iconostasis register

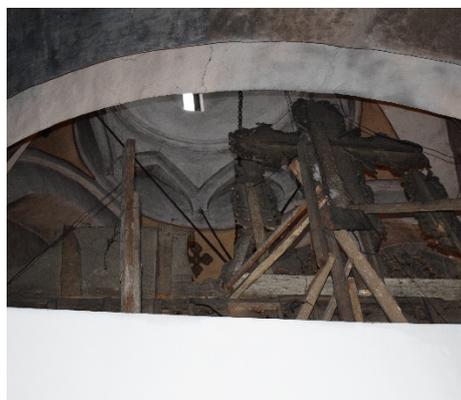
The back of the iconostasis is fixed by an anchoring system with elements of wood and metal (wires from time interventions on the iconostasis) on the built-in horizontal beams. Due to the presence of a false wall behind the iconostasis, made of drywall (unsuitable modern intervention, likely to provide some isolation of the altar space), it is not possible to accurately analyze the strength of the structure and state of conservation as also potential interventions in time to the reinforcement structure of the iconostasis. We appreciate that there are likely to be 3 or 4 built-in beams on which the iconostasis is anchored to. The anchorage structure is very likely to have been modified through interventions and changes over time.<sup>16</sup>

Fig. 14. Overall aspect of the upper part of the back of the iconostasis

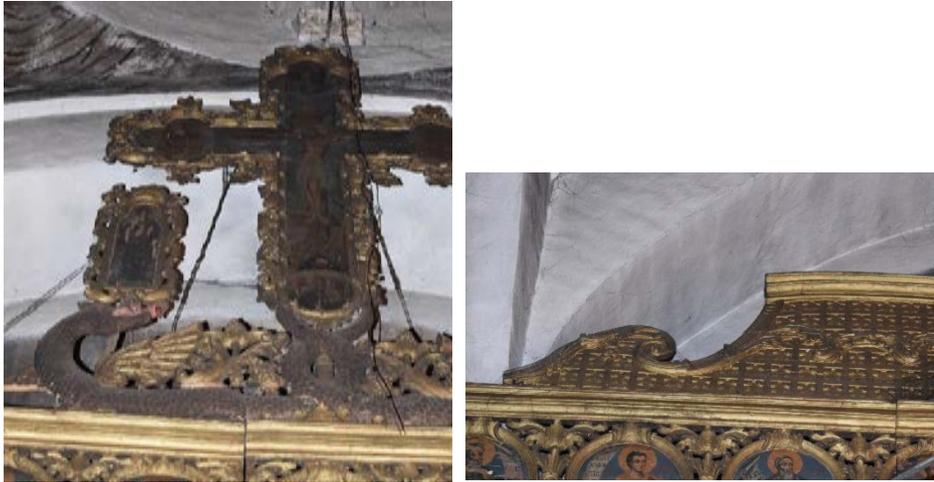
Fig. 15-16. Details of the “Coronament”

The cross with trefoiled extremities is painted with “Crucifixion” and the Four Evangelists at the ends. The painting is framed by a fretted, carved and gilded decorative border made up of stylized acanthus haulms. At the intersection of the arms the decoration is complemented by four groups of profiled rays.

The gryphons hold on the heads the two icons called “molenii” (the Mother of God and John the Evangelist painted as characters standing). In turn, these icons have decorative frames- fretted, carved and gilded, made up of stylized vegetal elements.

**Fig. 15-16.** Details of the “Coronament”

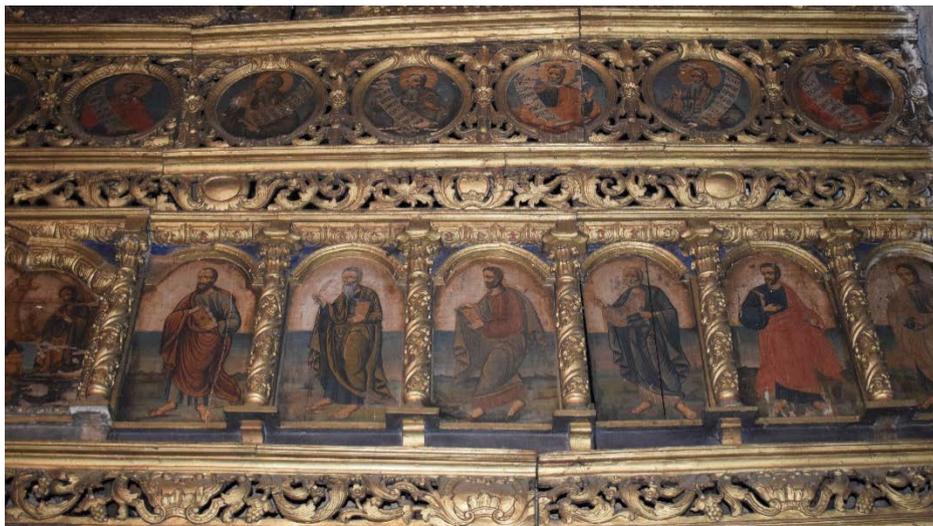
Fig. 17. Detail of the registers with the Prophets and Apostles

The register of **Prophets** consists of two friezes (strips) merged into the median axle. They are made by fretted and symmetrically sculpted decorative elements, which divide the 13 round icons, representing in the center the Mother of God in the “Oranta” aspect, flanked to the left and right by 6 icons with the Prophets. The round icons are carved from the thickness of the panel being framed by a high profiled rod, decorated with two volutes in the upper and lower median. The registry is limited by two heavily profiled wooden rods placed in console.

The icons are separated by semi-cylindrical columns placed on a pedestal. The columns decoration is made in a profiled torsade with the motif of the rose.

At the top, the icons present the gables ending with a curved wand decorated with the same motif as the frame of the icon “Deisis”.

**Fig. 17.** Detail of the registers with the Prophets and Apostles

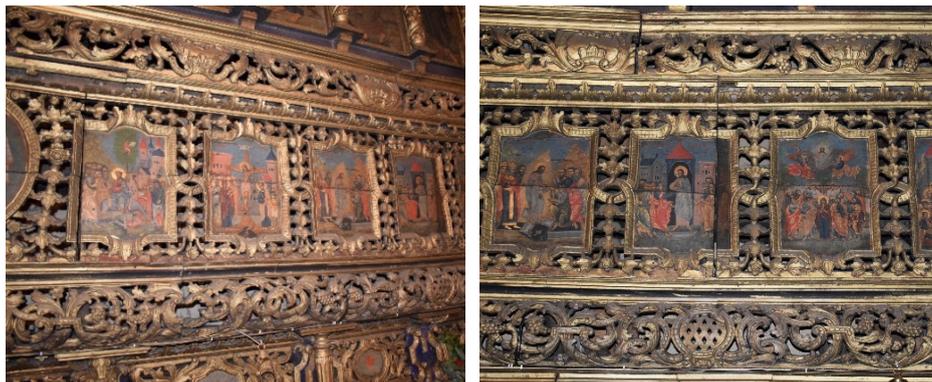
Fig. 20-21. Assembly and detail of a semi-frieze from the Holly Feasts register

The register with the **Main religious Holidays (Holly Feasts)** – dominates the Iconostasis ensemble. It consists of the Holly Feasts icons, limited to the upper and lower part of two semi-cylindrical decorative friezes, separated by the frieze of icons through profiled wands and decorative stripes with stylized leaves. The upper wand is slightly higher on the curvature of the central icon “Sf. Mahramă”, which has a quadrilobate shape, made from a wrinkled ribbon frame. The 12 icons are rectangular with frames made all of the wrinkled ribbon with the motif of the “foamed wave” at the top and bottom. The icons are separated by a strong fretted, symmetrical designed floral motif (tulips and haulms with roses).

The upper frieze with a curved plane is fretted with vegetable motifs (grapes and roses), interspersed by 6 bulging cartridges framed by wrinkled ribbons and stylized leaves.

The lower decorative frieze, carved in a curved plane, is decorated with a pattern of vegetal beanstalk woven with wrinkled ribbon and grapes, strongly marked by curves and counter curves. The decoration is interrupted by three oval medallions describing a grate from diamonds.

**Fig. 20-21.** Assembly and detail of a semi-frieze from the Holly Feasts register

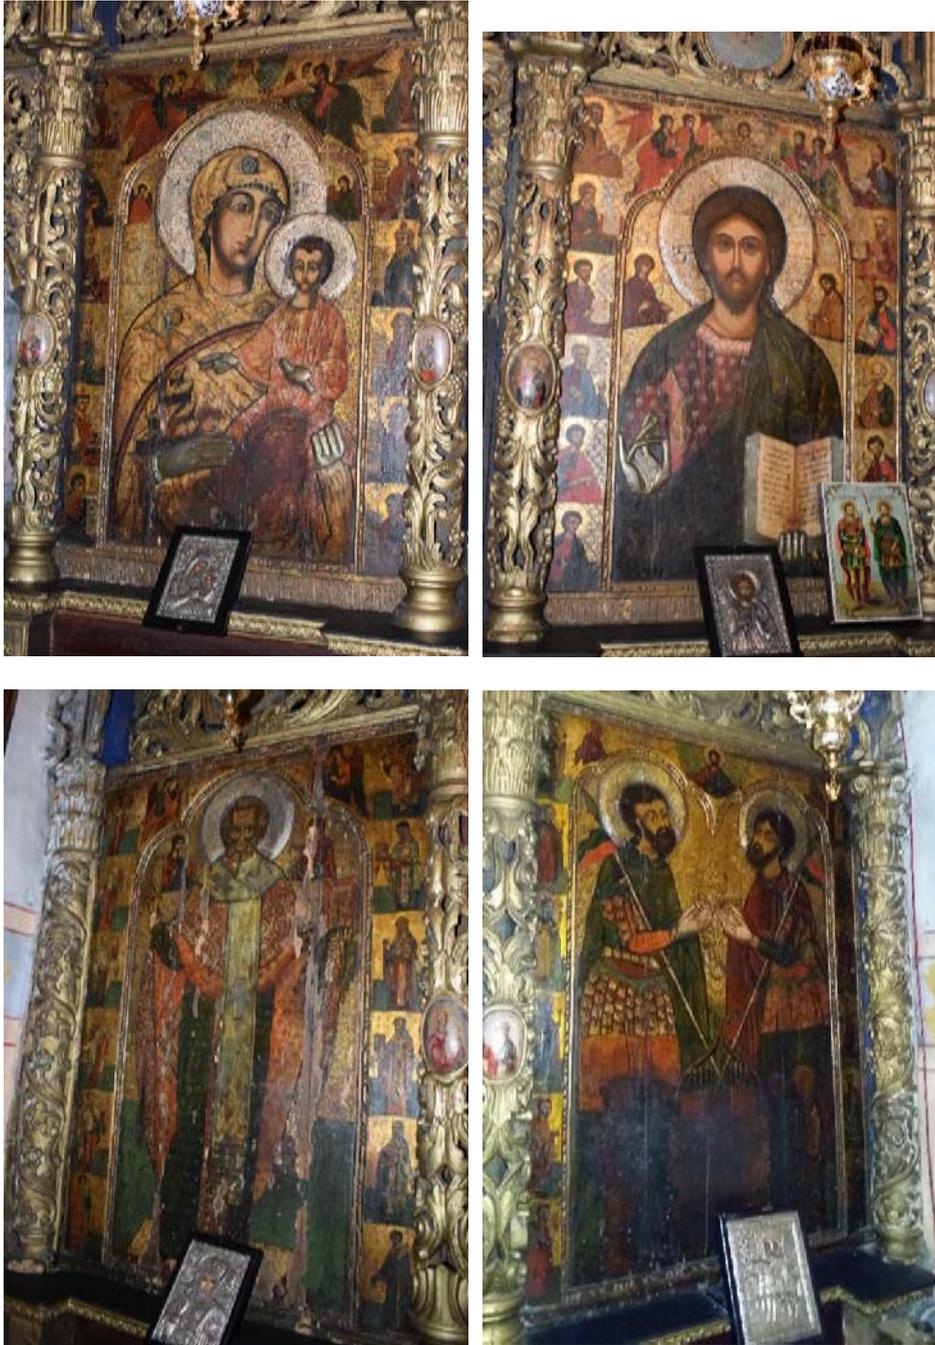
Fig. 26-29. Overall aspects of the Royal icons

From a stylistic point of view these icons constitute a special group, taking into account their representation with side scenes – of older tradition – and the background decorated with geometrical and floral elements in gilded relief. At the bottom of the icons there are inscriptions made in flat relief mentioning the donor *Solomon Bârlădeanu – Mare Vornic* – painted by “Unworthy painter Grigorie from Bierilești in the year 1665”.<sup>17</sup>

**Fig. 26-29.** Overall aspects of the Royal icons

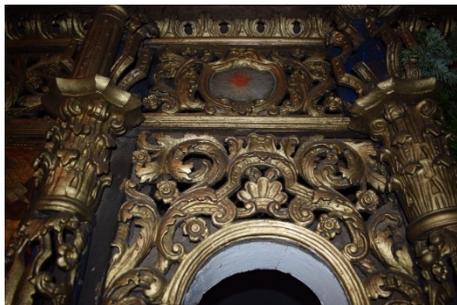
There are also present repaints of the gilded sculpted shape – application of a layer of “bronze” paint over the original decorated surfaces with metallic leaf (gold) and repainting of flat surfaces by covering them with one or more layers of paint (Foot Register and soffit of the doors of the Royal Register). You can also see partial repaints of the foot icons.

Fig. 32. “Bronze” repaints on carved shape

The decorative shape on the face of the iconostasis, carved, fretted and gilded, is fully repainted with a metallic pigment (bronze) dye distributed with scum and patchy thickness, with several reverts in some areas (especially in the lower parts). It was applied by coarse brushing in order to mask the degradations of the polychrome layer from the sculpted decorations.

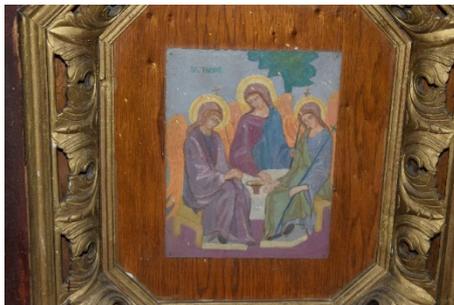
The image of these icons was subsequently overpainted in “fat” technique and does not respect the traditional iconographic program, here being represented (from left to right) the scenes: “Dinner at Emmaus”, “Fleeing Bethlehem”, “Healing of the Blind” and “Sf. George killing the Dragon”. The base pedestal is missing.

Fig. 33. Late interventions at the foot icons

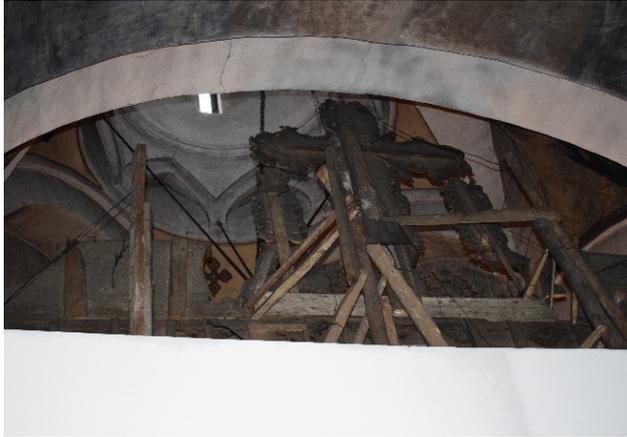
We mention the presence of metallic objects (nails, wires) of previous intervention with the role of securing the detached items from the iconostasis structure. These were used both at the sculpted and decorated part and for the reinforcement (insurance) of the iconostasis support elements (on the back). As far as the iconostasis's resistance structure is concerned, we note the use of new wood elements on the back of the iconostasis with the purpose of fixing the constituent parts to the built-in beams.

Fig. 34. Interventions at the resistance structure of iconostasis

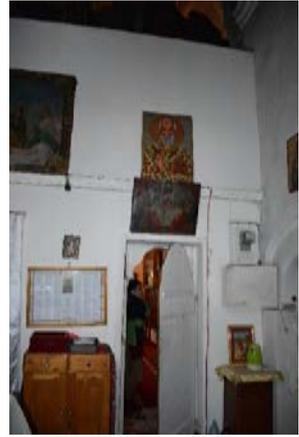
In the altar, behind the iconostasis, a false wall (gypsum boards), covering more than two-thirds of the iconostasis ensemble, was made likely to close the “gaps” and provide some sort of insulation for the Church’s altar area.

Fig. 35. False wall behind the iconostasis

At the back of the iconostasis are present staple accumulations of atmospheric particles (dust, smoke, tars), congested deposits being probably accumulated in the space created by the false wall closure of the back of the iconostasis towards the altar.

<sup>16</sup> It is necessary to remove the gypsum structure from Verso iconostasis in order to enable the preservation of the conservation status and the maintenance of conservation-restoration interventions at the level of the timber and support elements

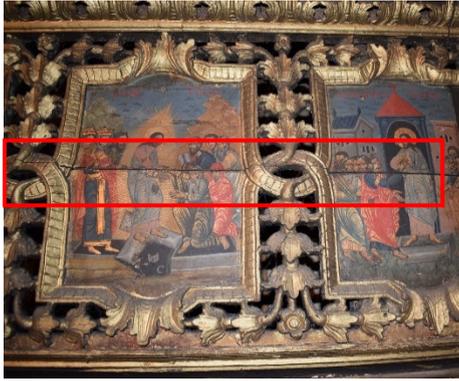
Due to these specific manifestations of wood fiber, the iconostasis elements have undergone numerous degradations that manifest by: splinting of fiber; takeoff of the sleepers; cracks on the wood fiber; detachment of component elements; deformations of flatness with partial or full takeoffs;

Fig. 36. Fractures on the wood merge

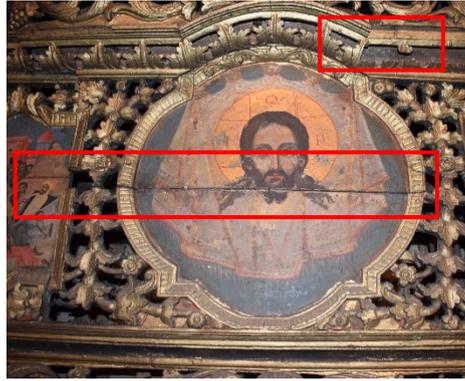
fractures; ruptures with partial or full loss of constituent elements, especially in the decorative part of fretted and carved wood.

Fig. 37. Distance fractures, gaps in carved shape

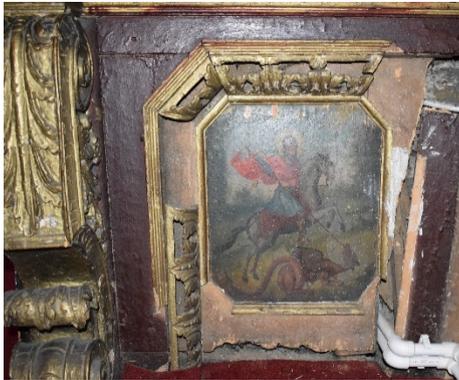
Fig. 38. Repaints, missing decorative elements

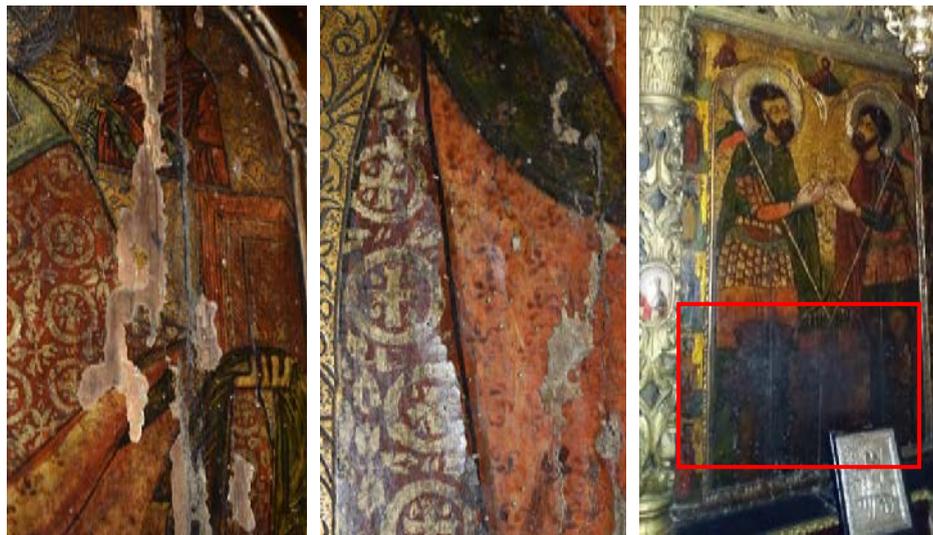
The loss of adhesion caused pictorial layer detachments (peels) and favored the appearance of gaps both at the level of the color layer and the primer (plaster). Wear and erosion are also present at the level of color layers.

The varnish layer is characterized by tonal changes (darkening) caused by the photochemical degradation that produced over time (aging). In different areas are reported matte spots due to the degradation in time, as well as the phenomenon of embedding the surface deposits.

Fig. 40. Gaps in the pictorial layer, degraded varnish

Fig. 41. Detachment, peels, gaps

Fig. 42. Embedded deposits
