# MODALITIES OF VISUALLY LOCATING THE INTERVENTION AREAS IN THE RESTORATION DOCUMENTATION

Bogdan Gavrilean\*

**Abstract:** The aim of the present article is to present modalities of visually locating the areas of specific intervention within heritage buildings, using vector graphics and bitmap image software, employed in the framework of preservation-restoration documentation.

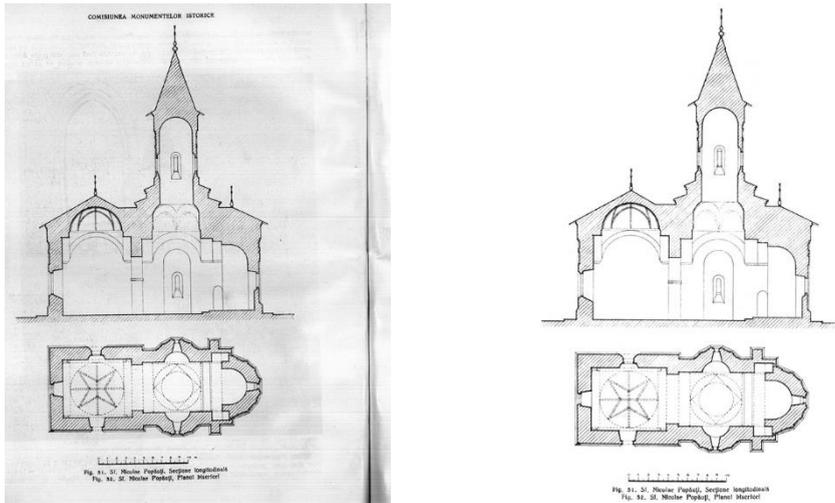
Fig. 1, 2. The church of Popăuți, Botoșani (15<sup>th</sup> century)<sup>3</sup>.  
Ground plan and axial cross-section.

In a first stage, the printed images of the cross-sections and ground plans are digitized by high-resolution scanning<sup>4</sup>, an example of such scanned and non-processed image is illustrated in Fig. 1. The images are then processed by means of bitmap image processing software such as Adobe Photoshop, which allows the rotation of the image, the cutting-out of the irrelevant areas and the blotting out of as much noise as is possible out of the background<sup>5</sup>, as illustrated by Fig. 2.

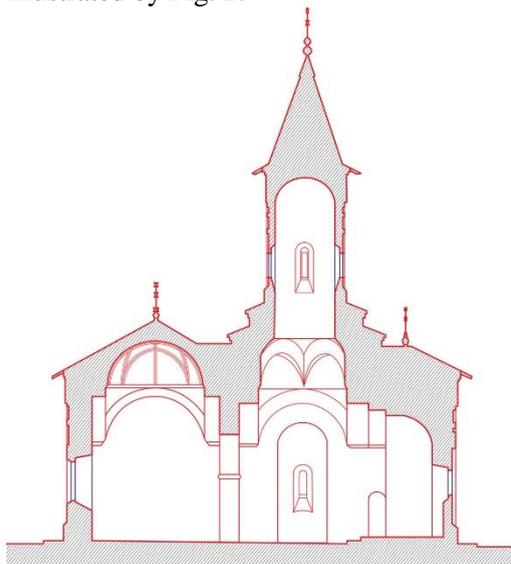
Fig. 3. The church of Popăuți, Botoșani (15<sup>th</sup> century).  
Axial cross-section redrawn using CorelDraw

The corrected bitmap image is then used as model for the precise redrawing of both the ground plan and the axial cross-section, using the CorelDraw software (see Fig. 3 and 4, which illustrate the vector graphics of Popăuți church, drawn by the author in CorelDraw), achieving in the end a detailed vector graphic.

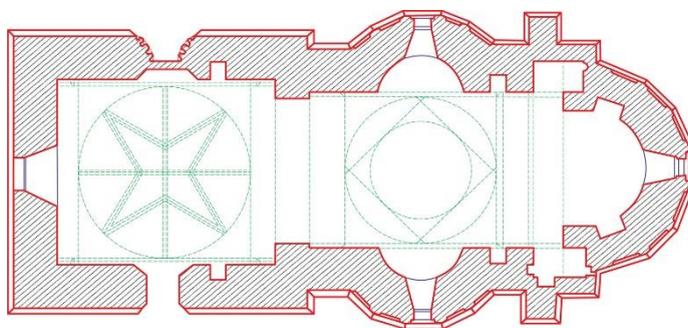
Fig. 4. The church of Popăuți. Ground plan, redrawn using CorelDraw

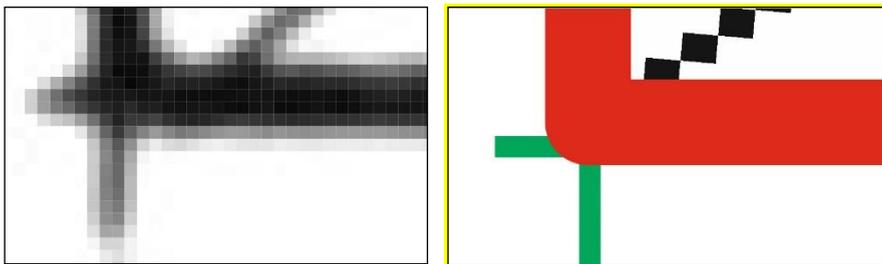
Fig. 5, 6. 300 dpi – scanned bitmap image (left) and vector graphic drawn in CorelDraw (right)

The main advantage of this type of images is the small storage space it takes, as well as the fact that the information is easy to correct and to update compared to hand-drawings, which, on any modifications must be practically redrawn completely from zero. Another advantage is the fact that the vector graphics can be scaled to any physical dimensions, the resulting image being of the same print quality, both in small and in very large formats, compared to the bitmap images, where the aliasing effect shall appear eventually, regardless of the resolution<sup>6</sup>. Fig. 5 and Fig. 6 illustrate the difference in quality between images, both presenting a detail of the ground plan of the church of Popăuți monastery, both zoomed up to 2100%: bitmap (left) and vector (right).

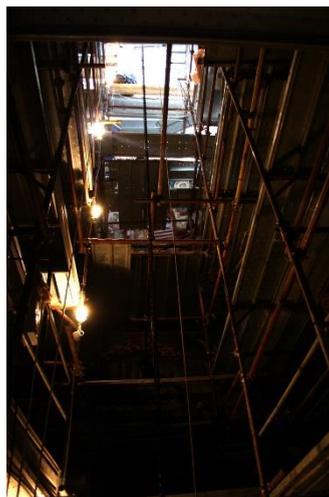
Fig. 7. Scaffolding inside Golia monastery church

When the wall painting decorations are undergoing restoration, the obtaining overall scene photographs of high quality is more difficult, as the presence of the scaffolding obscures almost entirely the visibility of such scenes, e.g. the scaffolding erected in the nave of Golia monastery church for the restoration interventions (see Fig. 7).

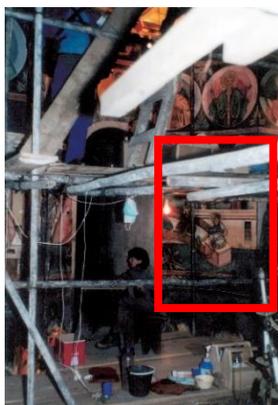
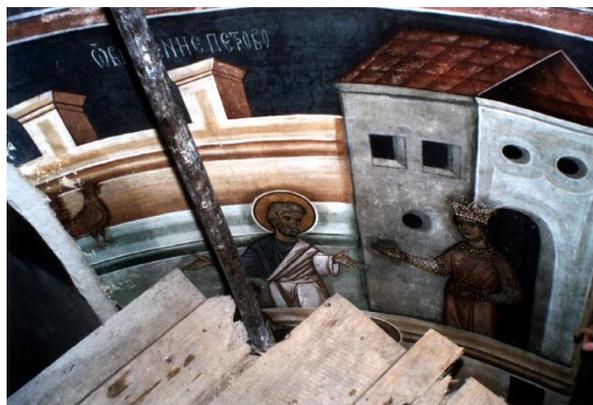
Fig. 8, 9. The scaffolding inside Popăuți monastery church – general view of the “The Denial of Peter” scene – which is located on two decks of the scaffolding (left) and detail of the scene (right).

In these conditions, obtaining a single contiguous image of the work area is difficult, due to the extremely tight photographing angles onto the work area from the decks of the scaffolding, as the scaffolding “cuts” the image in several horizontal or vertical sections, the larger scenes being sometime located on even two or three registers). Fig. 8 illustrates the repartition on two registers of the “The Denial of Peter” scene in the church of Popăuți monastery, Botoșani, while the detail in Fig. 9 outlines the area between two registers, covered by scaffolding, and only visible from a very tight angle.

In the most frequent situations, though, the various scaffolding members interfere with the view of the scene, as illustrated by the examples in Fig. 9 – 11 and 13, showing the metal members of the scaffolding.

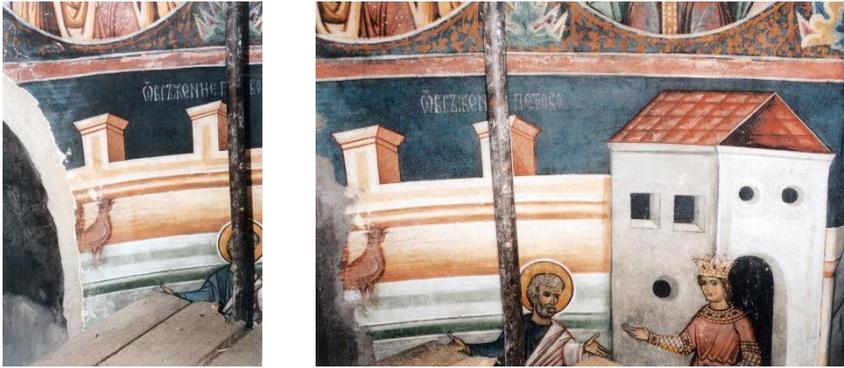
Fig. 10, 11. Popăuți monastery church – “The Denial of Peter” scene.  
Metal members of the scaffolding

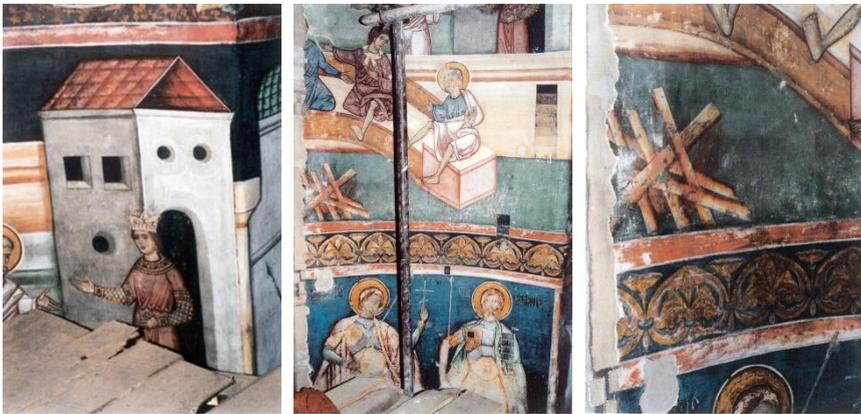
Fig. 12, 13, 14. Popăuți monastery church – “The Denial of Peter” scene.  
Scanned images of the photographs taken on the upper (left)  
and lower half of the scene (center and right)

The only effective option in this situation remains the photographing of the scene from multiple angles (Fig. 9 - 14), followed by the digital stitching together of the images using Adobe Photoshop. The preliminary procedures are identical to the first phase, with the difference that in this latter phase, the images are processed, both to eliminate the perspective distortions (due to the atypical photographing angles, as illustrated by Fig. 9 – 14, on “The Denial of Peter”) and to eliminate the chromatic aberrations generated during the image acquisition (photographing and then scanning).

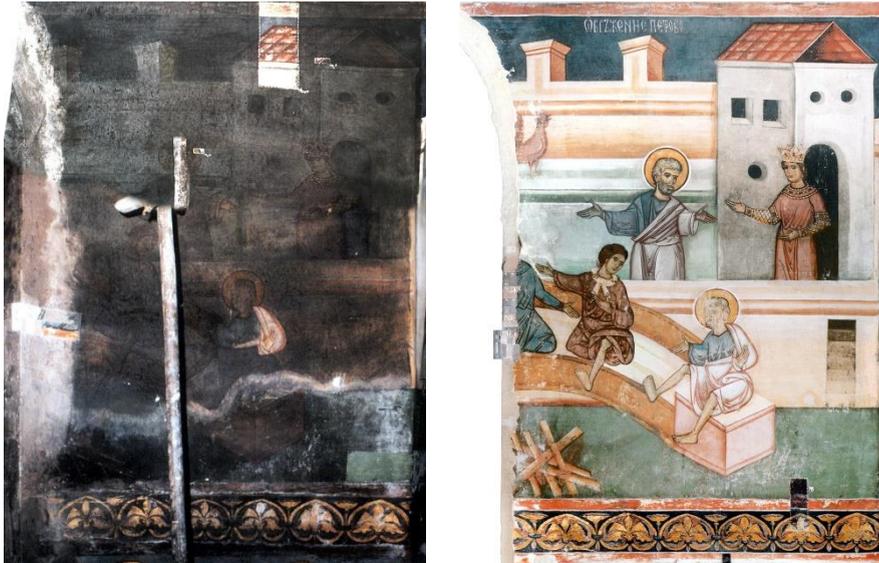
Fig. 15, 16. “The Denial of Peter”. Images stitched in Photoshop.

Following the rescaling to the same size and the correction of perspective deformations for each image individually, the image segments are juxtaposed in Adobe Photoshop to obtain the general image of the work area. The assembled image in Fig. 15 illustrates the state of preservation of the scene before restoration, while Fig. 16 illustrates the scene close to the end of restoration operations.

One must mention that, although the final assembled images are superior to the hand-drawings of the scenes, these do not have an absolute degree of precision, as certain errors are inevitable, either from a chromatic point of view or in relation to certain dimensional reference points. However, the digitally assembled images fulfil the purpose, i.e. to provide a whole-picture image without the interference caused by the scaffolding.

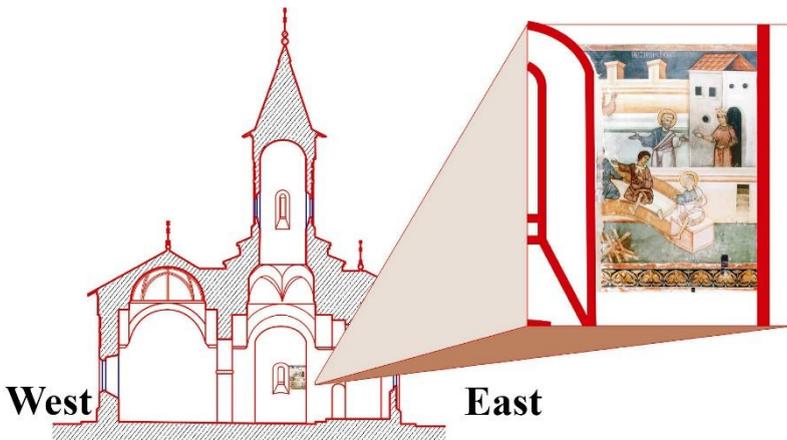
Fig. 17. The location of the wall painting decoration using the axial cross-section.

The assembled bitmap image is then resized and located within the vector drawing of cross-section (as illustrated by Fig. 17) and the ground plan (Fig. 18) of the church.

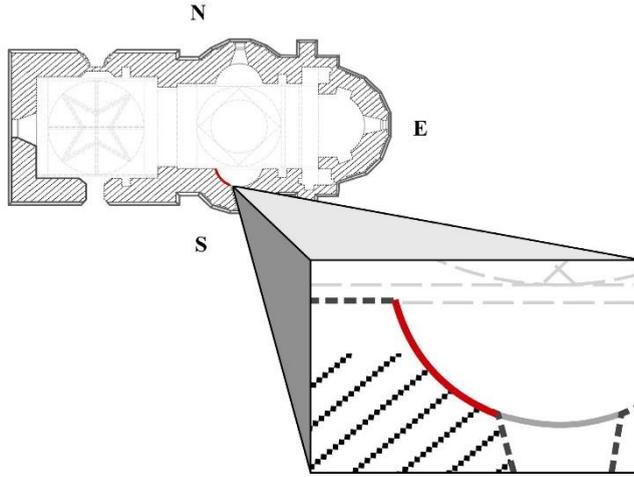
Fig. 18. The “Denial of Peter” scene, located using the ground plan

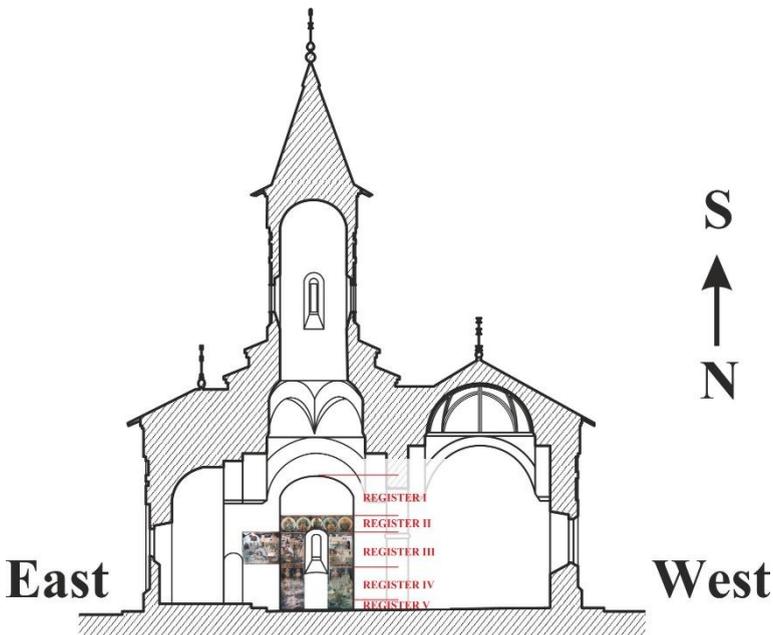
Fig. 19. The visual location on registers, using the axial cross-sections

The composite method of visual location for the specific areas of intervention, within the whole church heritage building, is presented by the image in Fig. 19, in which the contiguous images of the restored wall painting decorations are illustrated using the cardinal points within the axial cross-section, while Fig. 20 shows a detail with the repartition of scenes on registers. This method can also be extended to the graphical documentation that are always attached to the restoration documentation.

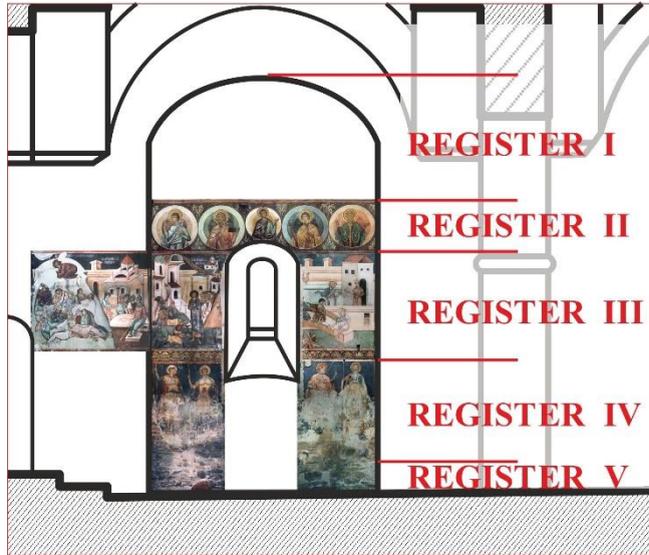
Fig. 20. The visual location of the frescoes, using the axial cross-sections (detail).

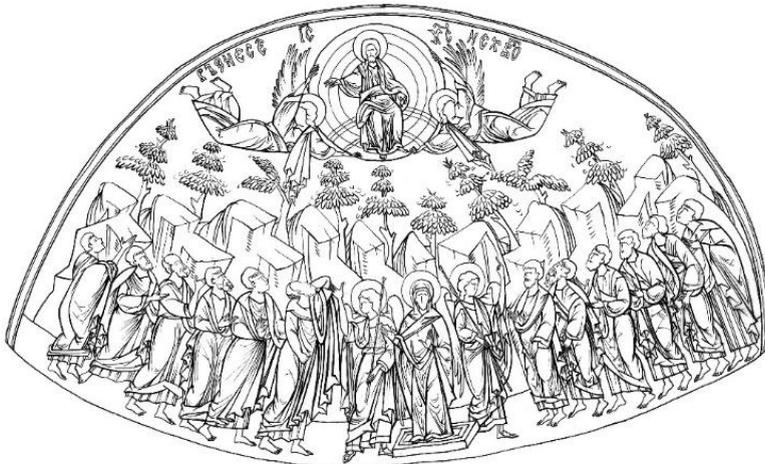
Fig. 21. Hand-drawn outline representation of the “Ascension of Jesus” scene

Fig. 21 represents a measured outline hand drawing, of the “Ascension of Jesus” scene, St. Nicholas church, Popăuți, Botoșani, which was subsequently scanned and assembled in Adobe Photoshop.

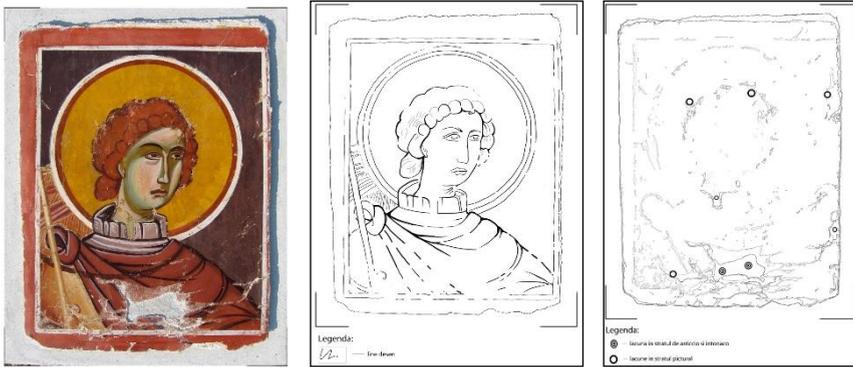
Fig. 22, 23, 24. Image used as background (left), outline drawing (center) and digital graphic representation of the state of conservation (right) of an extracted wall-painting decoration

To conclude, we exemplify the two main types of elaboration of graphical reliefs: the elaborations that use integrally digital technologies are presented in Fig. 22-24<sup>9</sup>, while the elaborations that use hand-drawings on tracing paper are illustrated in Fig. 25-29<sup>10</sup>.

Both types of elaborations are accompanied by explanatory graphical captions, which are located, in Fig. 22-24 below the drawing, while in Fig. 25-29 on the right side of the drawing.

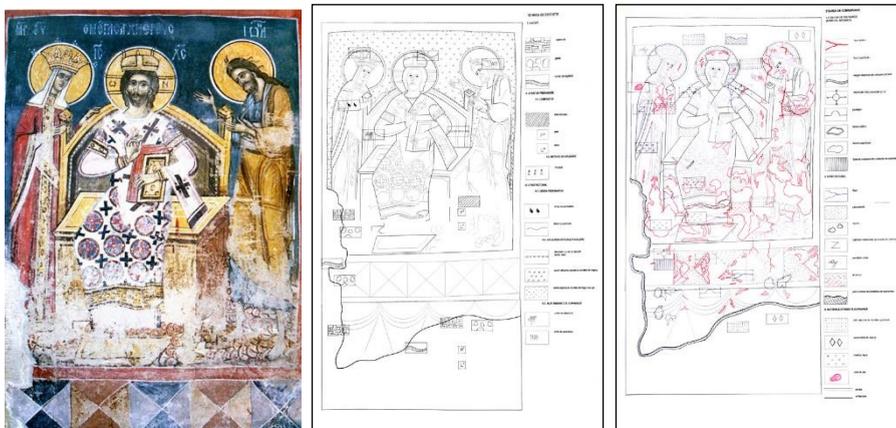
Fig. 25, 26, 27. The general image of the “Deisis” scene, the church of Moldovița Monastery (left); Hand-drawn graphic representation illustrating *The Outline drawing of the scene and the Execution technique* (center), and *State of preservation of the preparation layers* (right)

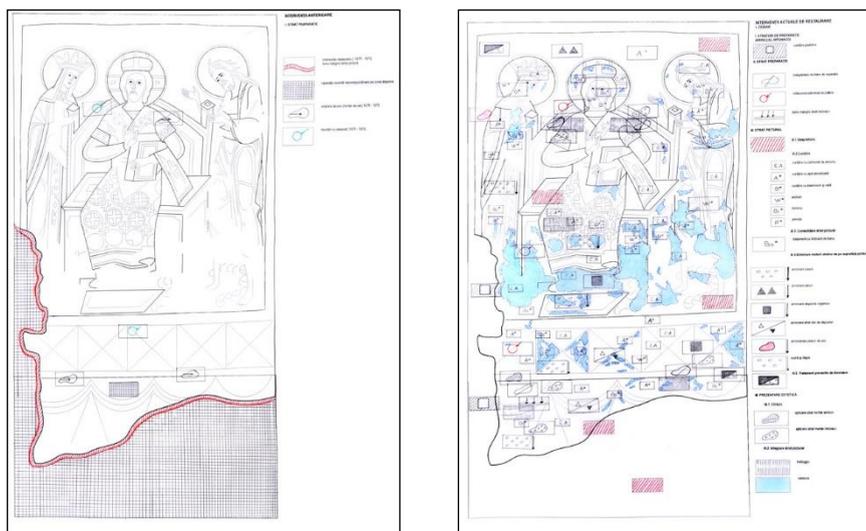
Fig. 28, 29. Hand-drawn graphic representation of the “Deisis” scene, illustrating the *Prior interventions* (left) and the *Current restoration interventions* (right).
